REGION 5 Enforcement and Compliance Assurance Division

INSPECTION REPORT

Inspection Entry Date/Time:	11/29/2022 9 AM	Announced: Yes				
Inspection Exit Date/Time:	11/29/2022 2 PM	Access: Granted				
Weather:	Clear conditions					
Media:	Water					
Statute(s)/Program(s):	Safe Drinking Water Act and Title 35, Subtitle F of the Illinois Administrative Code (Ill. Adm. Code)					
Type of Inspection:	CEI – Compliance Evaluation					
In-Person Inspection:	Yes					
System Name: Stateville Correctional Center						
System Physical Address: 16830 Illinois State Route 53,						
Facility/Site Identifier: 110018324687						
(City, state, zip code) Crest Hill, Illinois, 60434						
County/Borough/Parish: Will						
Environmental Justice Area: Yes						
PWS ID: IL1977910						
Persons Participating in Inspection:						
Name	Title/Organization	Phone	Email	Present in Opening Conf.	Present in Closing Conf.	Present during Site Walkthrough
Taylor Girouard	Lead Inspector/EPA	312-353-1394	girouard.taylor@epa.gov	Yes	Yes	Yes

Taylor Girouard and the inspection team, arrived at the Stateville Correctional Center (the “System”), located at 16830 Illinois State Route 53, Crest Hill, Illinois, 60434, at 9

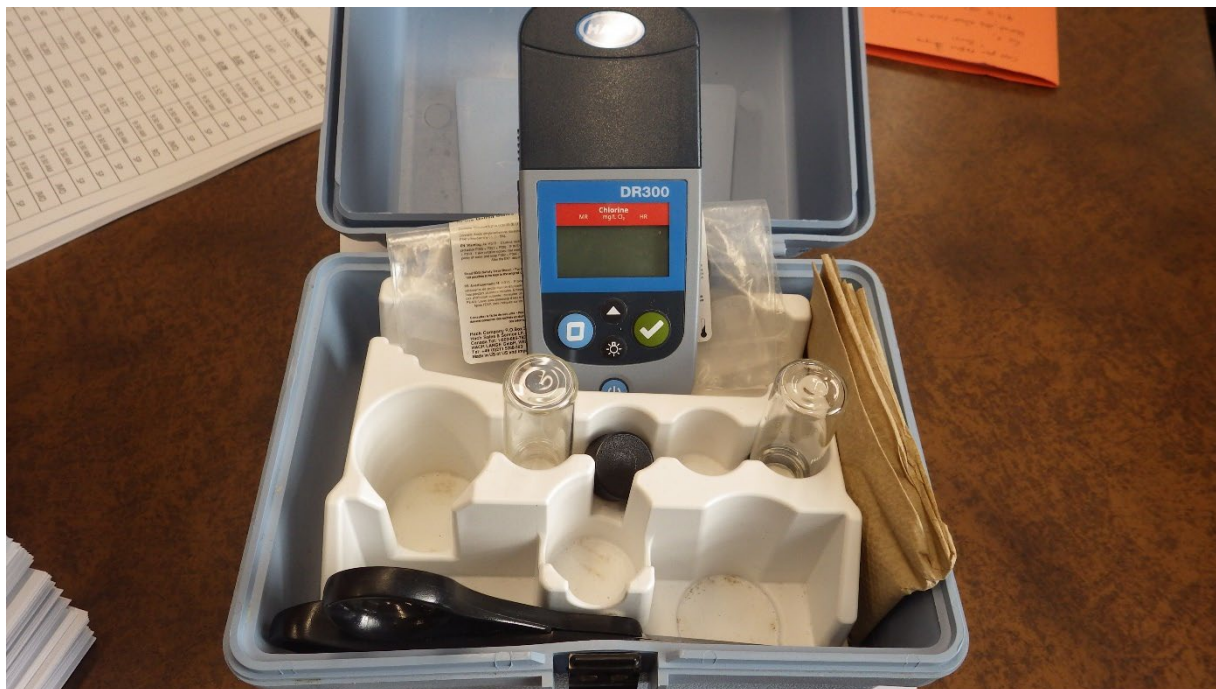
Photo 1

Description: System's HACH DR300 Pocket Colorimeter used to collect residual chlorine measurements when doing RTCR sampling and other spot measurements for chlorine residuals throughout the water system.

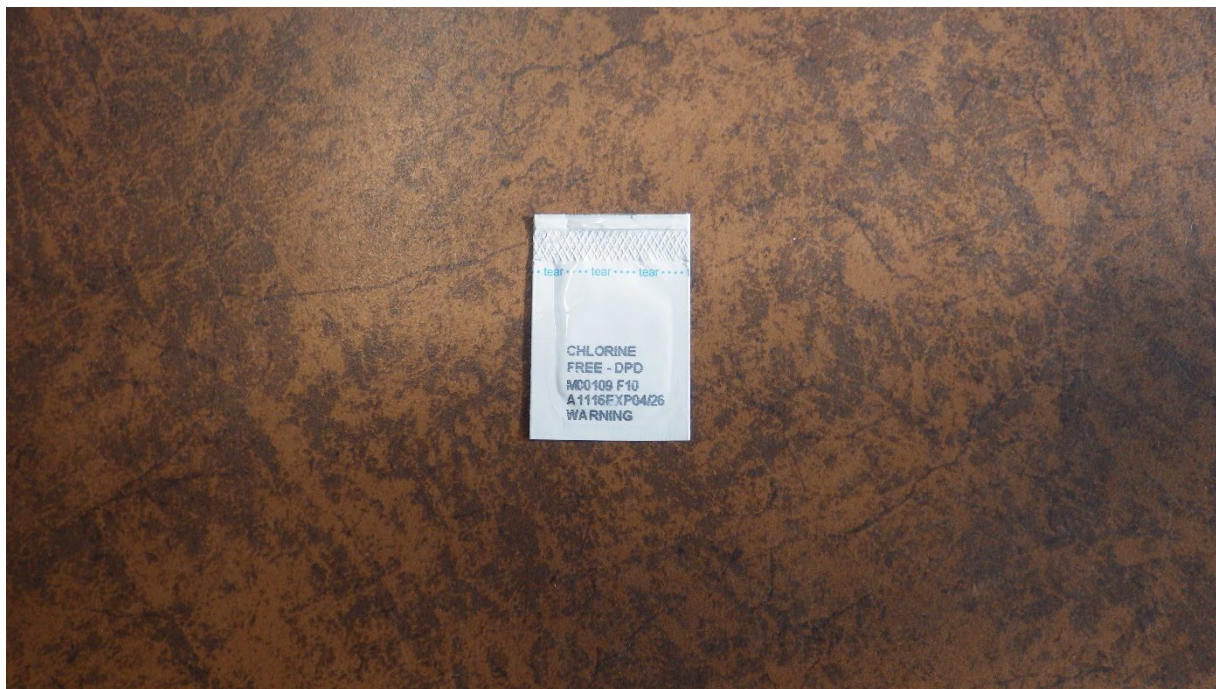
Photo 3

Description: Duplicate of Photo 2.

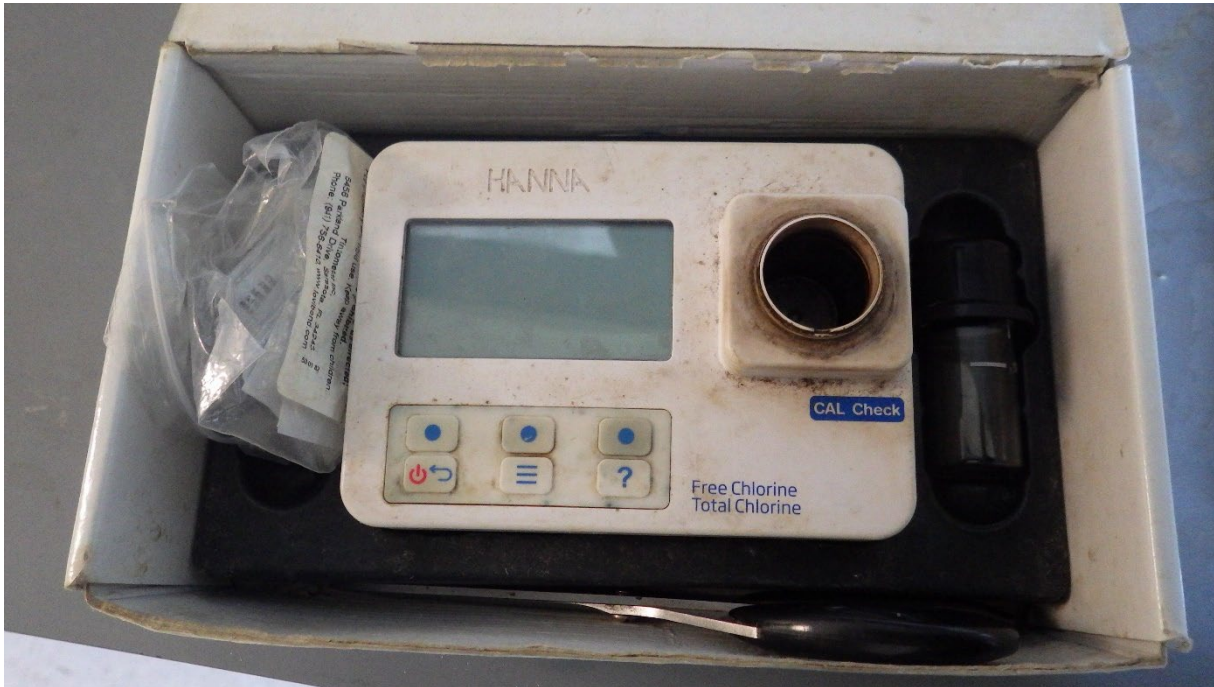
Photo 4

Description: HANNA Free and Total Chlorine Photometer that the System uses to measure free chlorine in daily water samples collected from the water tower.

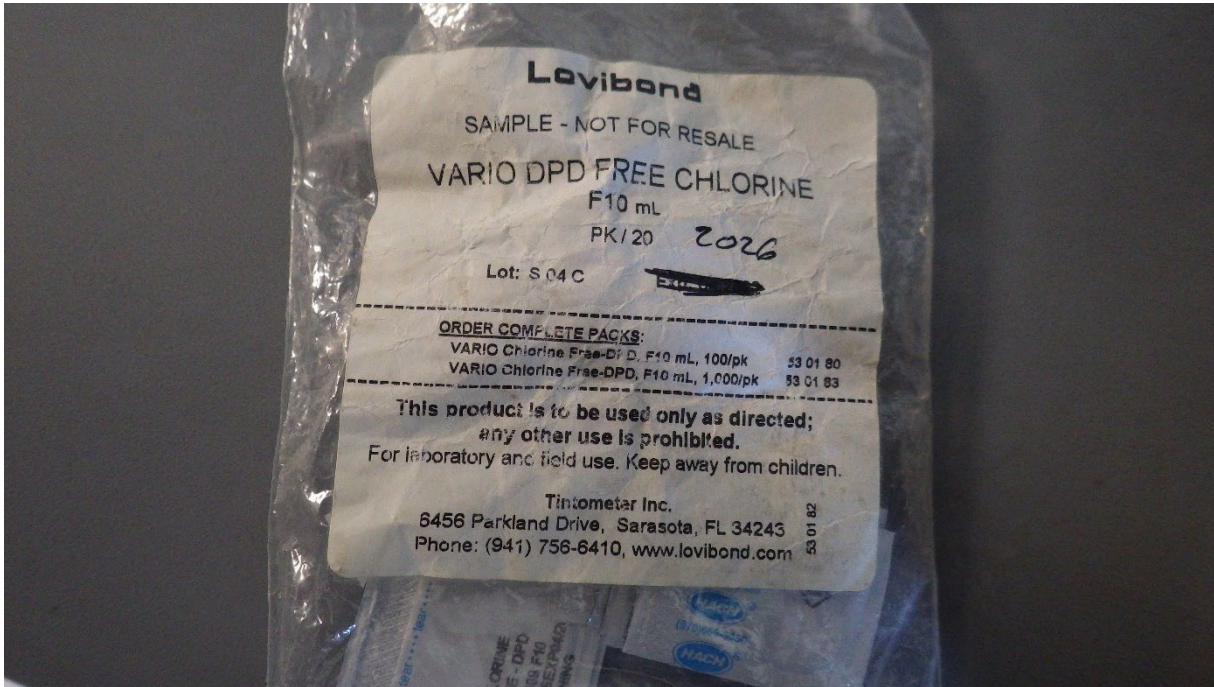
Photo 5

Description: Bag of free chlorine reagent packets that the System stores with the HANNA Free and Total Chlorine Photometer.

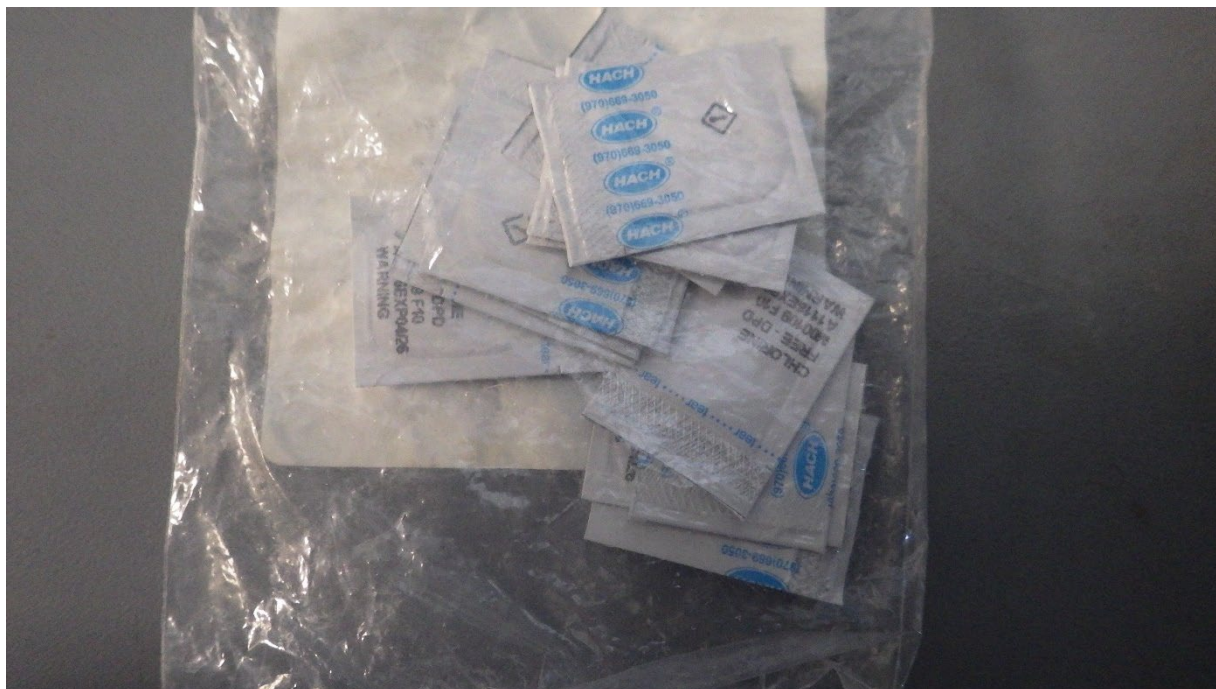
Photo 6

Description: A second photo of the bag of free chlorine reagent packets that the System stores with the HANNA Free and Total Chlorine Photometer.

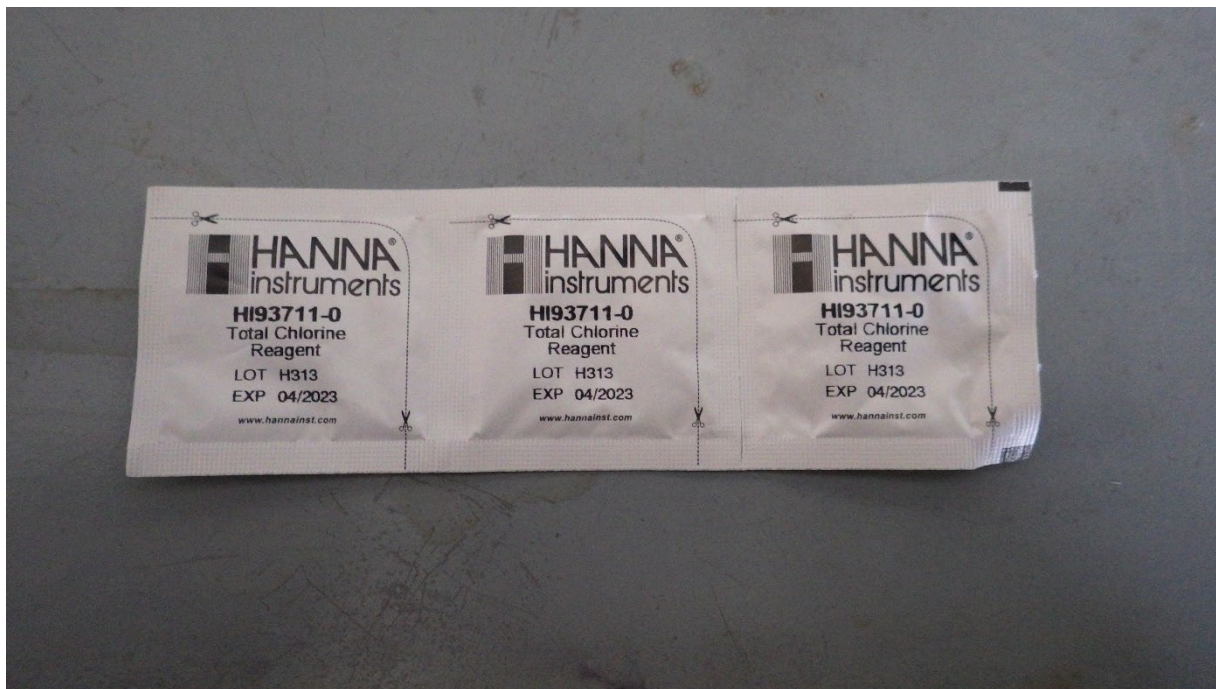
Photo 7

Description: Total chlorine reagent packets.

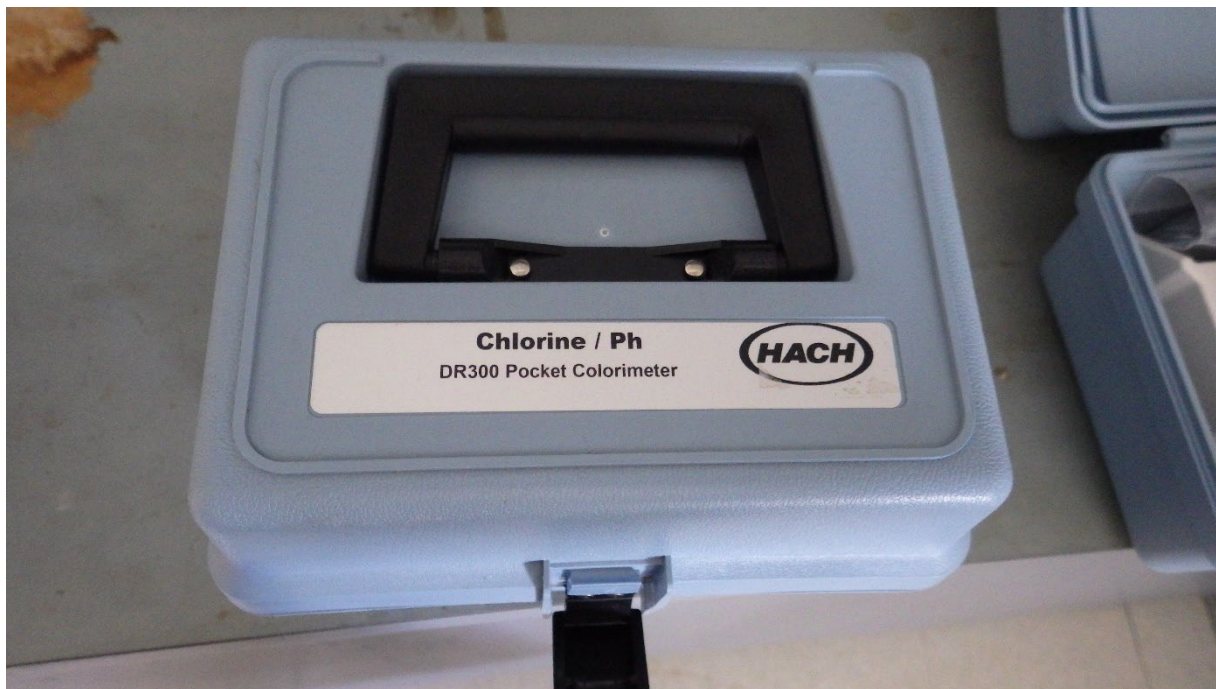
Photo 8

Description: HACH DR300 Pocket Colorimeter that the System uses to measure pH.

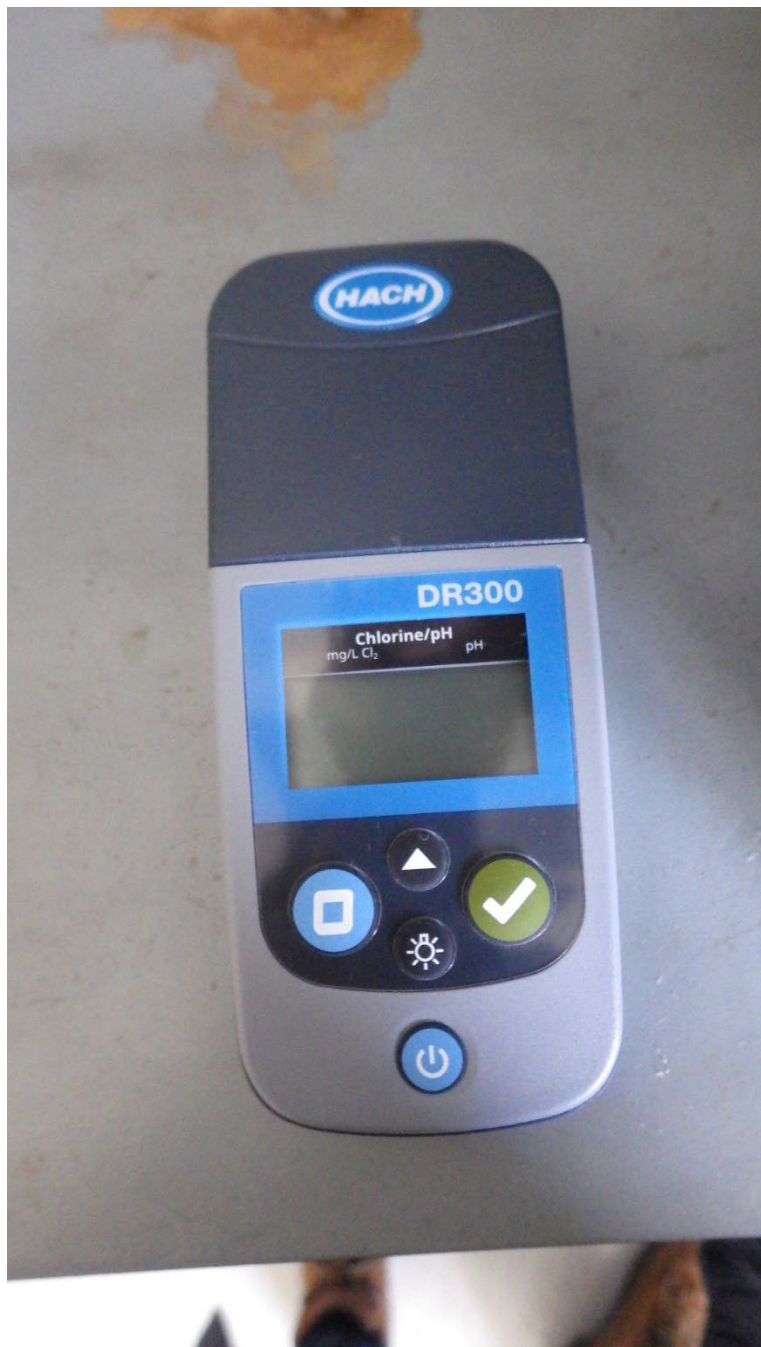
Photo 9

Description: HACH DR300 Pocket Colorimeter that the System uses to measure pH.

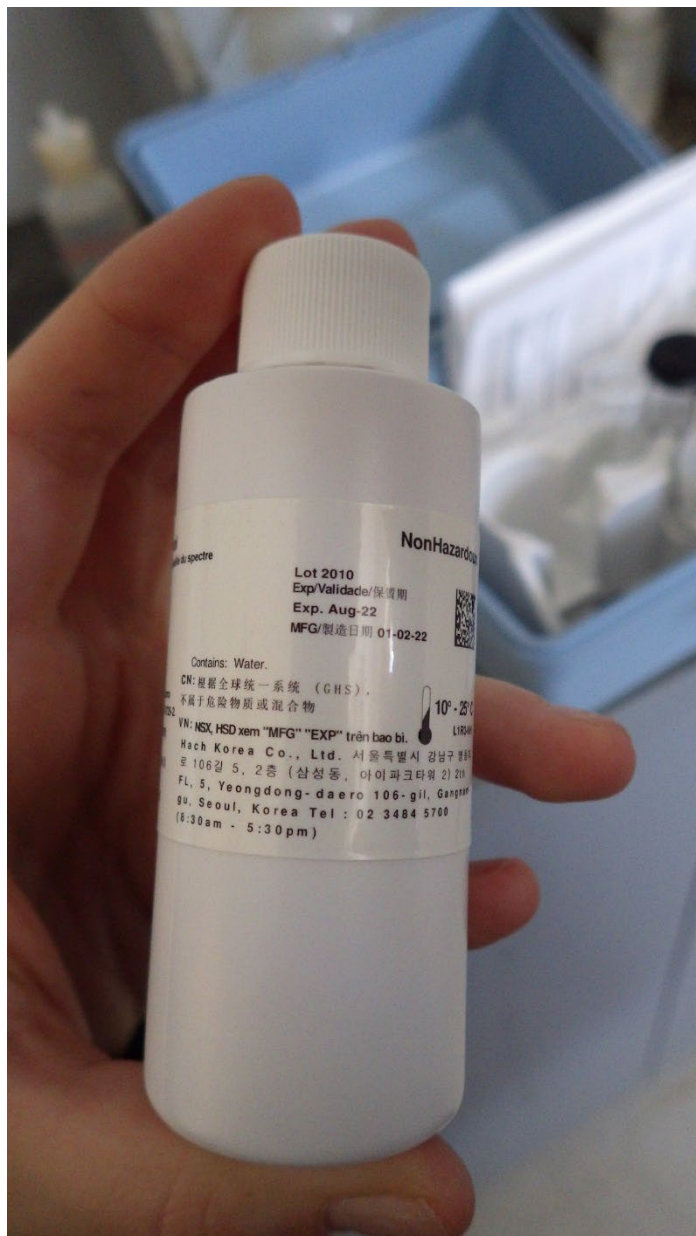
Photo 10

<p>Additional Notes:</p>	
<p>Area: Powerhouse Lab</p>	
<p>AOC Reference #: OB-003</p>	
Regulation:	NA
NA	
<p>AOC: While inside the powerhouse lab EPA identified that the Phenol Red indicator solution expired in August of 2022.</p>	
<p>Additional Notes:</p>	
<p>Area: Water Tower</p>	
<p>AOC Reference #: OB-004</p>	
Reference:	Recommend Standards for Water Works (10 State Standards) and American Water Works Association (AWWA) Standards
NA	
<p>AOC: The overflow pipe and water lines inside of the water tower were severely rusted and peeling. AWWA and 10 State Standards recommend finished water storage structures be assessed and inspected (both internal and external) every 5 years to ensure the structures have mechanical integrity and do not pose threat to finished water quality.</p>	
<p>Additional Notes:</p>	
<p>AOC Reference #: OB-005</p>	
Regulation:	NA
NA	
<p>Inside of the water tower EPA observed that a check valve was broken and was continuously leaking water. The stated that it has been leaking for many years.</p>

Description: Phenol Red indicator solution used to measure pH. This solution expired in August of 2022.

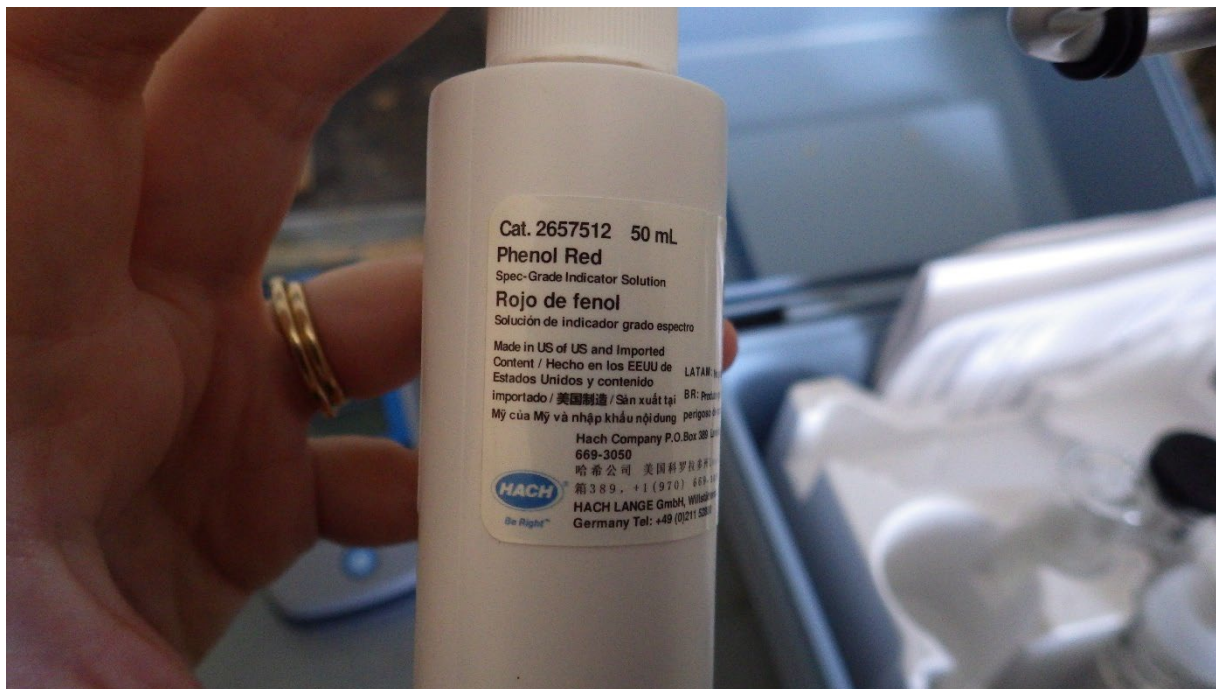
Photo 11

Description: A second photo of the Phenol Red indicator solution used to measure pH.

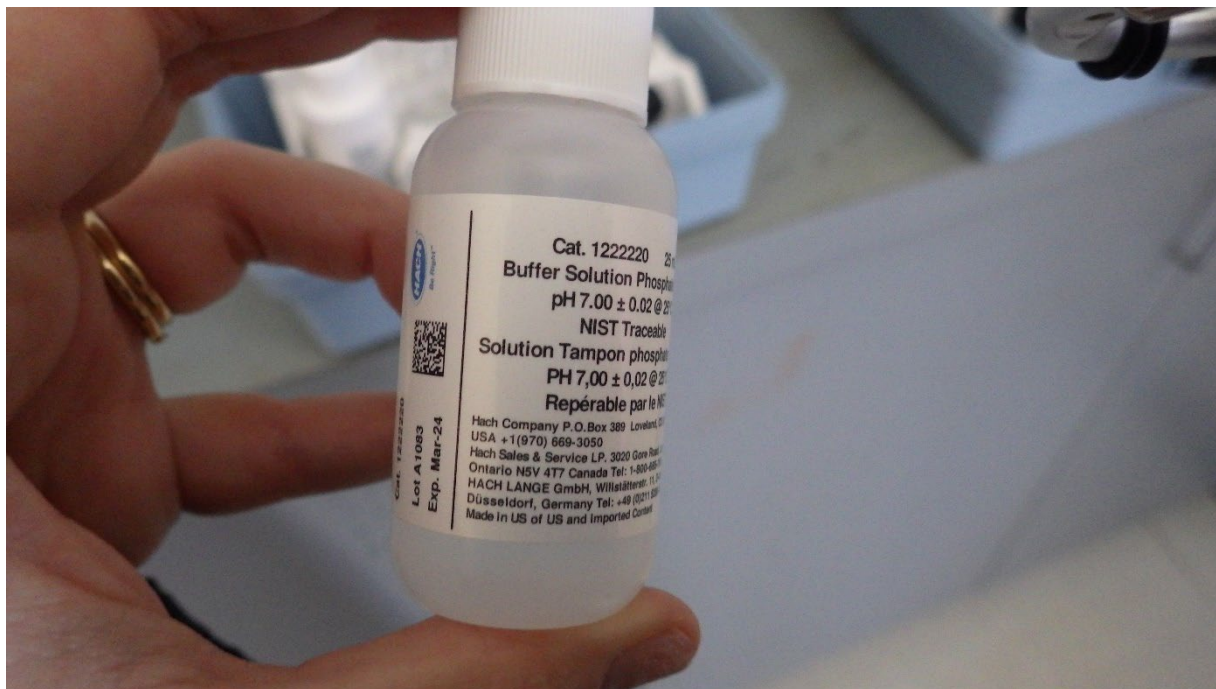
Photo 12

Description: Buffer solution for the HACH DR300 Pocket Colorimeter that the System uses to measure pH.

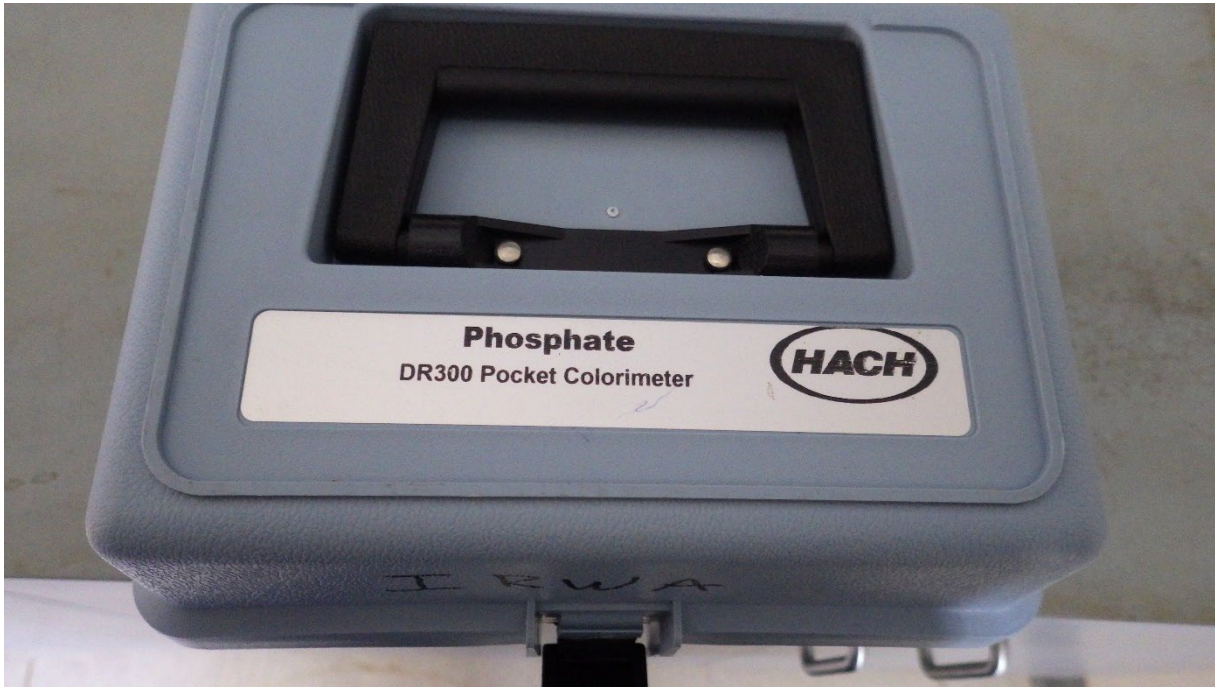
Photo 13

Description: HACH DR300 Pocket Colorimeter that the System uses to measure phosphate.

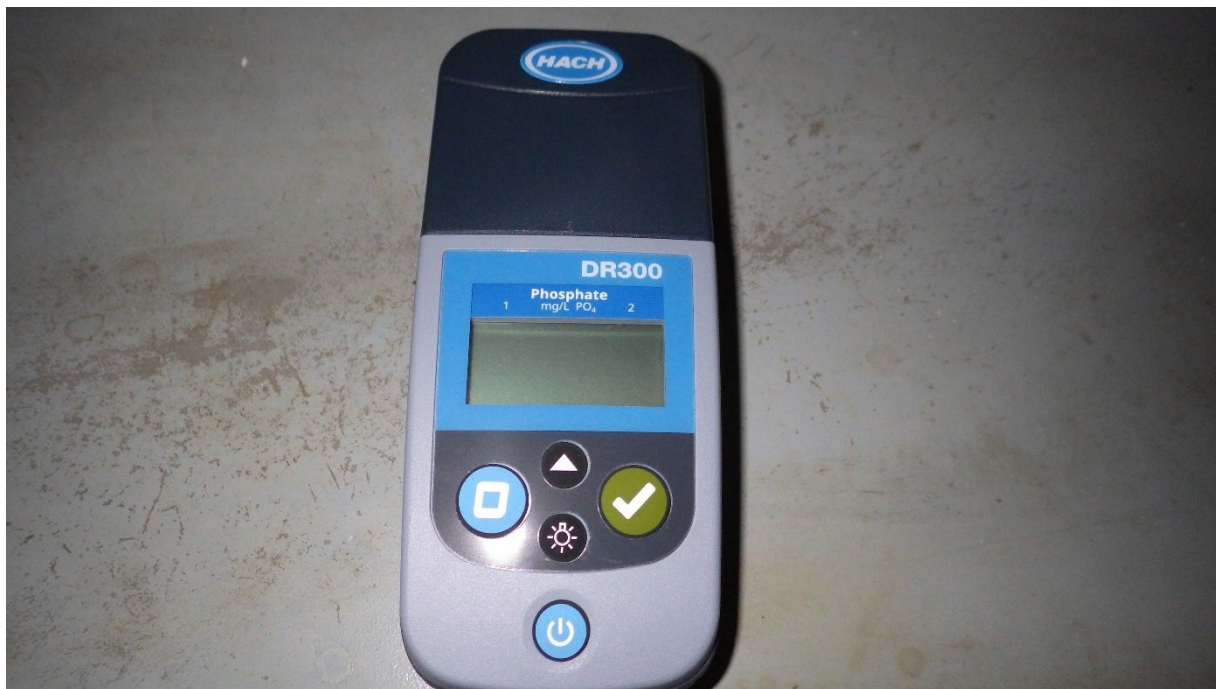
Photo 14

Description: HACH DR300 Pocket Colorimeter that the System uses to measure phosphate.

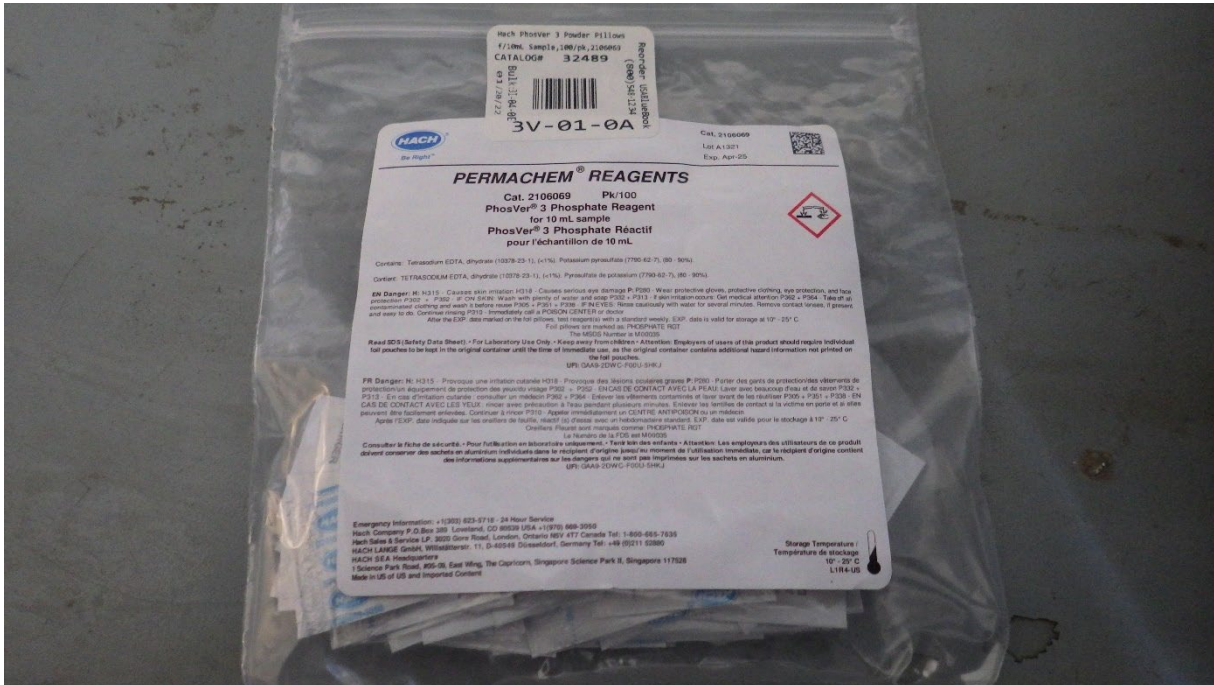
Photo 15

Description: Phosphatereagent packets.

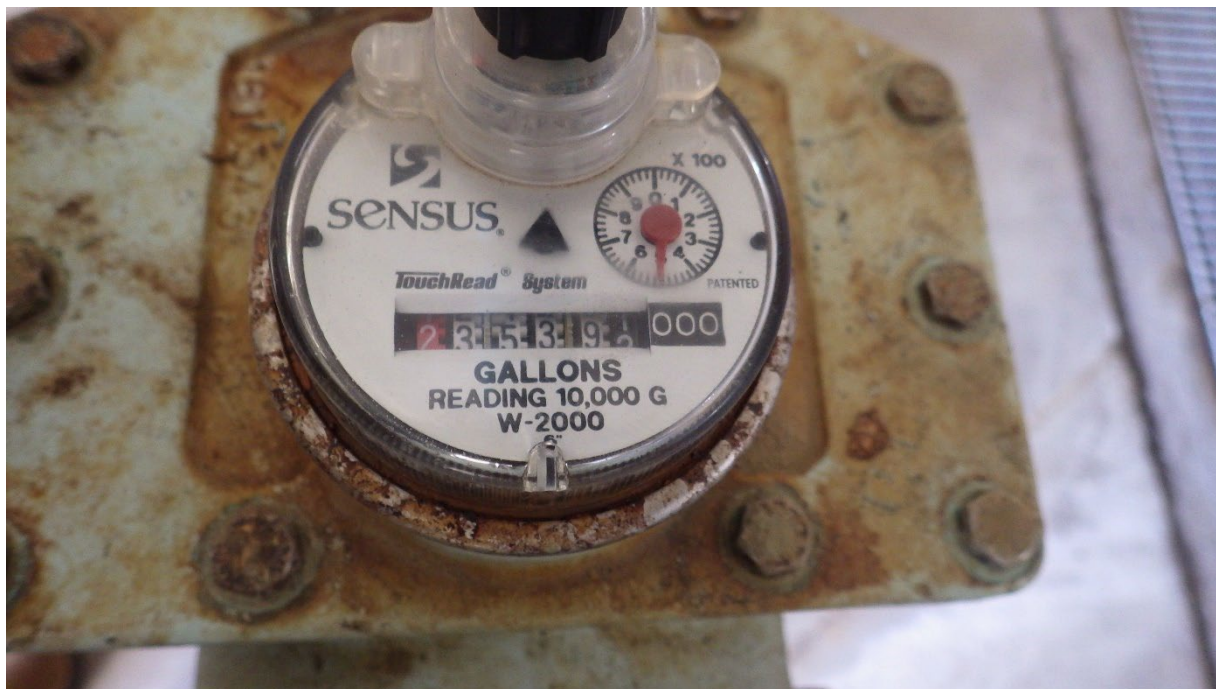
Photo 16

Description: Master water meter located on the incoming water line inside the water tower. At the time of inspection the meter read approximately 235,392,000 gallons.

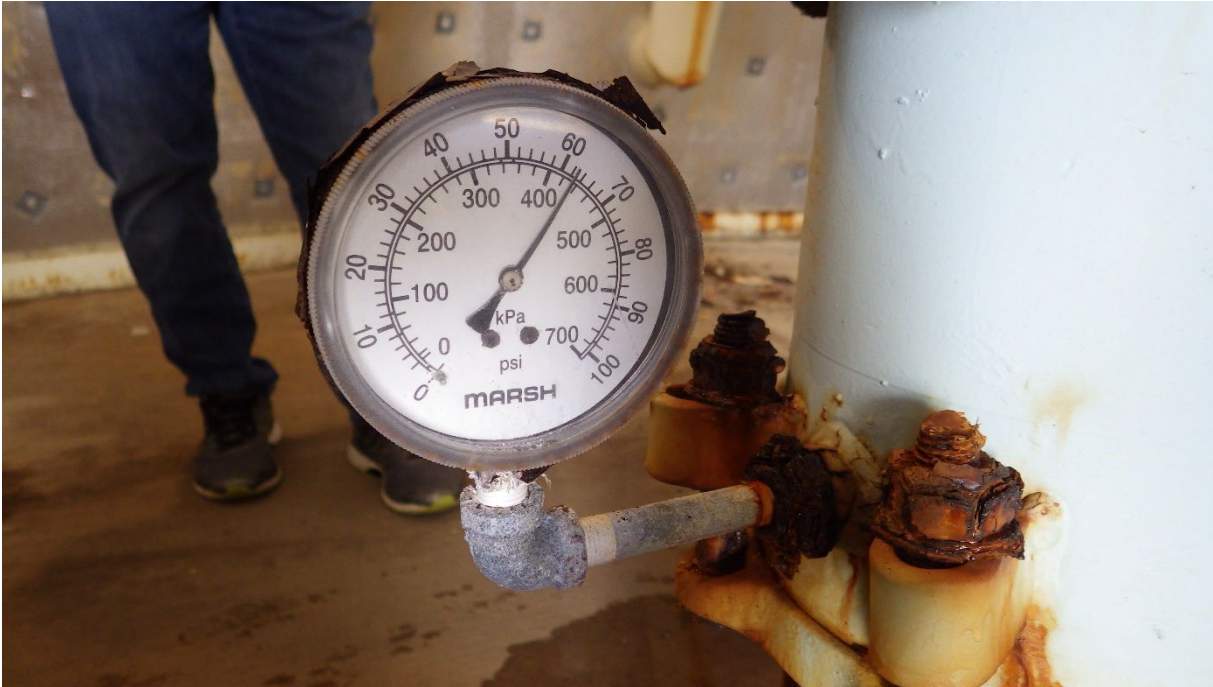
Photo 17

Description: Master pressure gauge located on the incoming water line inside the water tower. At the time of inspection the meter read approximately 63 psi.

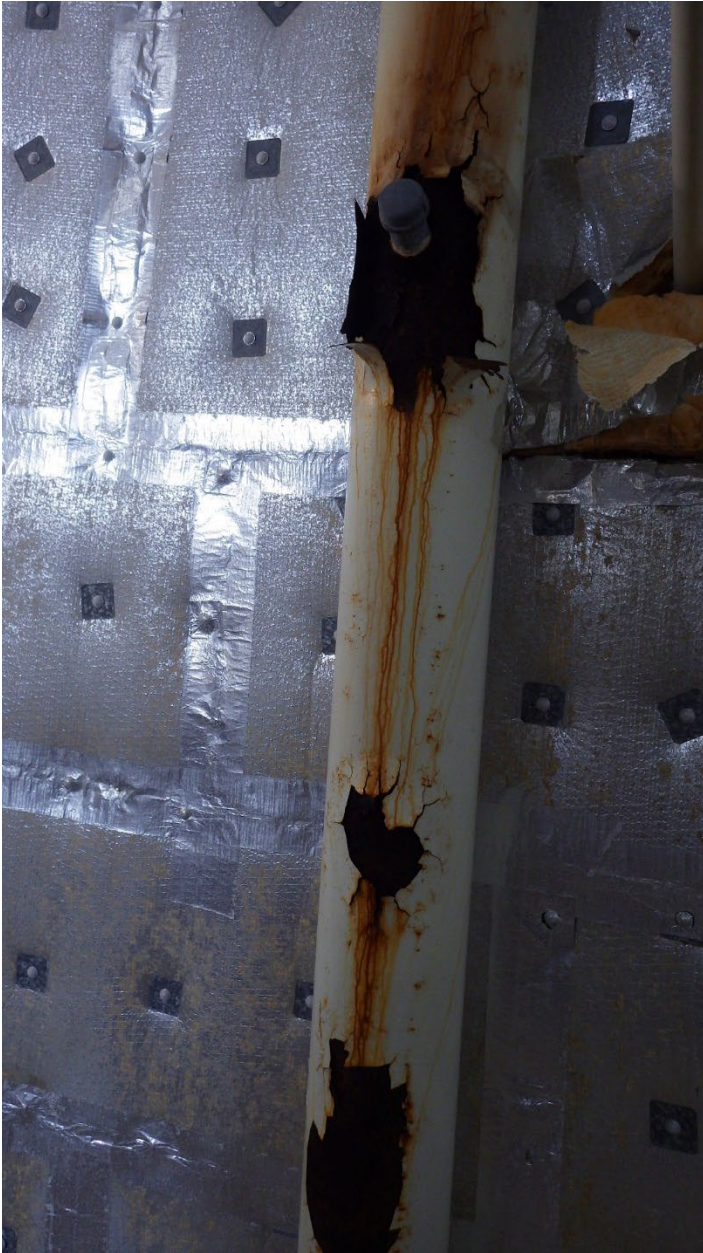
Photo 18

Description: Part of the overflow pipe for the water tower located inside the water tower.

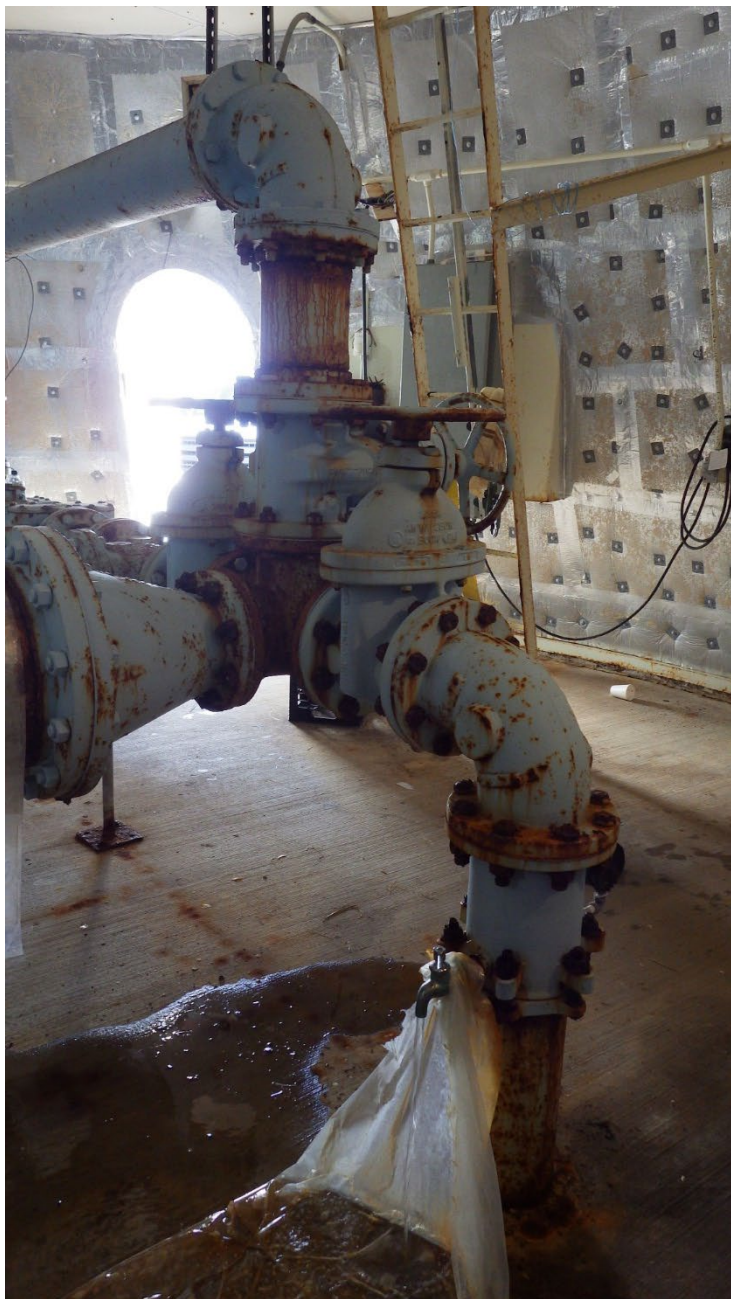
Photo 19

Description: Sample tap located inside of the water tower. This sample tap is located on the incoming water main for the System.

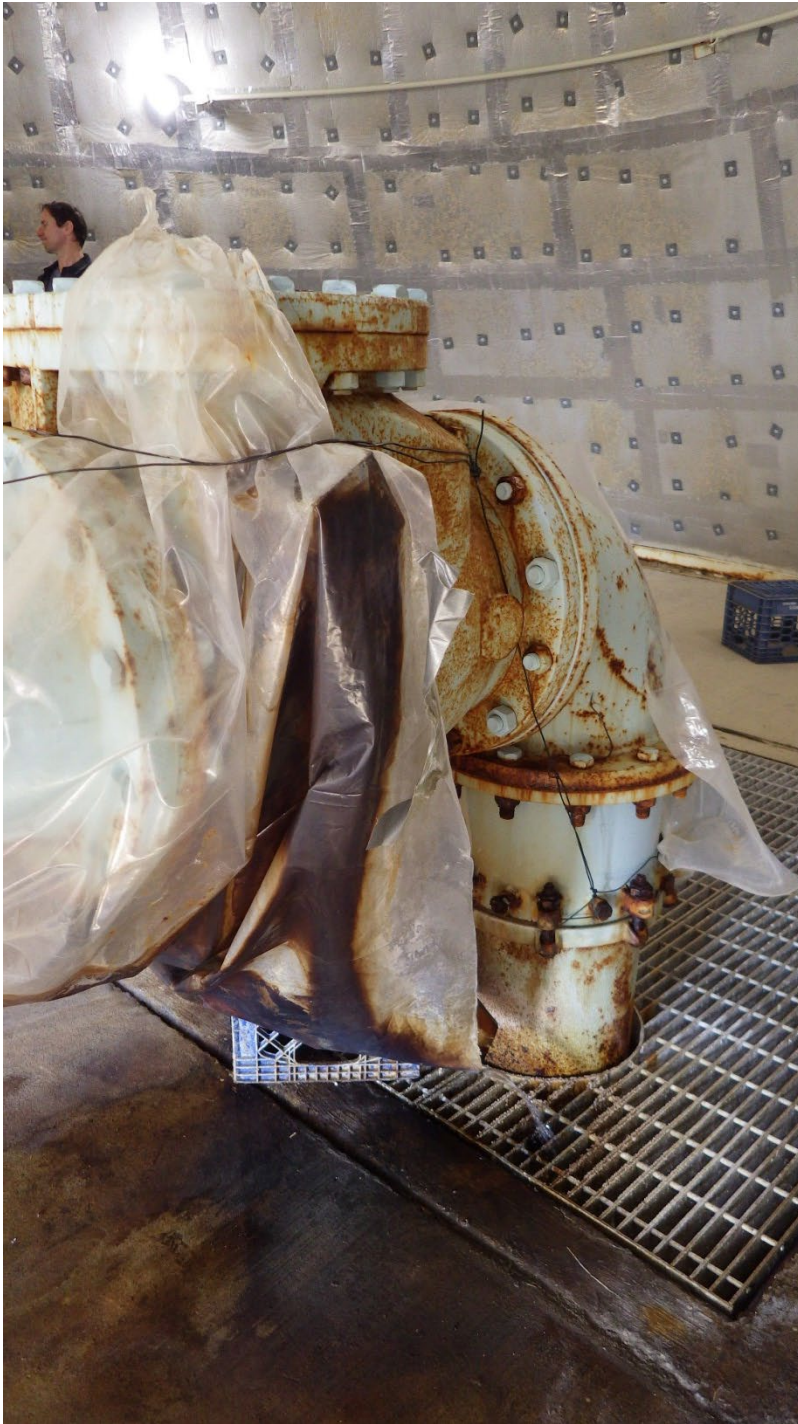
Photo 20

Reference #: OB-003	AOC: Yes
While inside the powerhouse lab EPA looked at the System's analyzers for pH and orthophosphate. The System had two HACH DR300 Pocket Colorimeter devices, one each dedicated to pH and orthophosphate monitoring. When looking at the expiration dates for the reagents and solutions inside each of the two kits EPA identified that the Phenol Red indicator solution expired in August of 2022.	
Photo(s): Appendix A Photos 8, 9, 10, 11, 12, 13 and 14	
Area: Water Tower	
Reference #: OB-004	AOC: Yes
The overflow pipe and water lines inside of the water tower were severely rusted and peeling.	
Photo(s): Appendix A Photos 18, 19, 20 and 21	
Reference #: OB-005	AOC: Yes
Inside of the water tower EPA observed that a check valve was broken and was continuously leaking water. The System had a tarp over the pipe that contained the check valve to direct the leaking water into an underground pit. The System had a sump pump inside the pit that moved water from the pit inside the water tower to the ground outside. The area around the exterior base of the tower was flooded with the water being pumped out of the pit by the sump pump. The System stated that the valve has been broken and leaking for several years.

Description: Check valve on the water main inside of the water tower. At the time of inspection the check valve was broken and finished water can be seen leaking from the valve and draining into a pit.

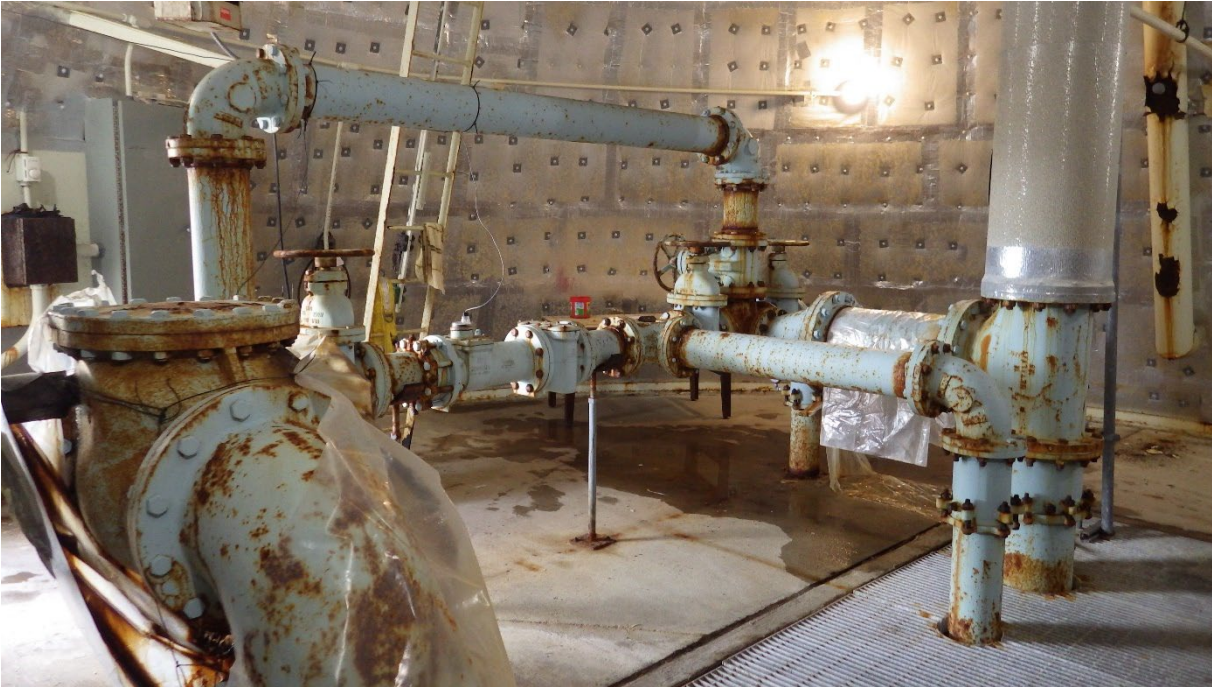
Photo 21

Description: Interior of the water tower.

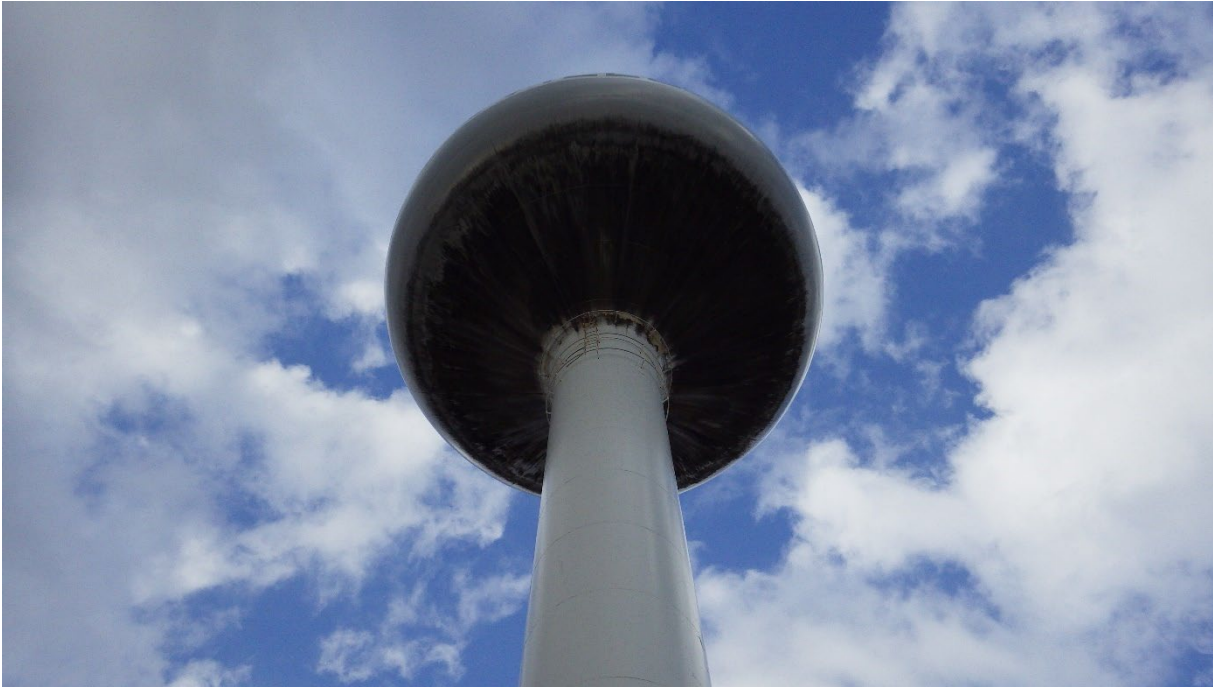
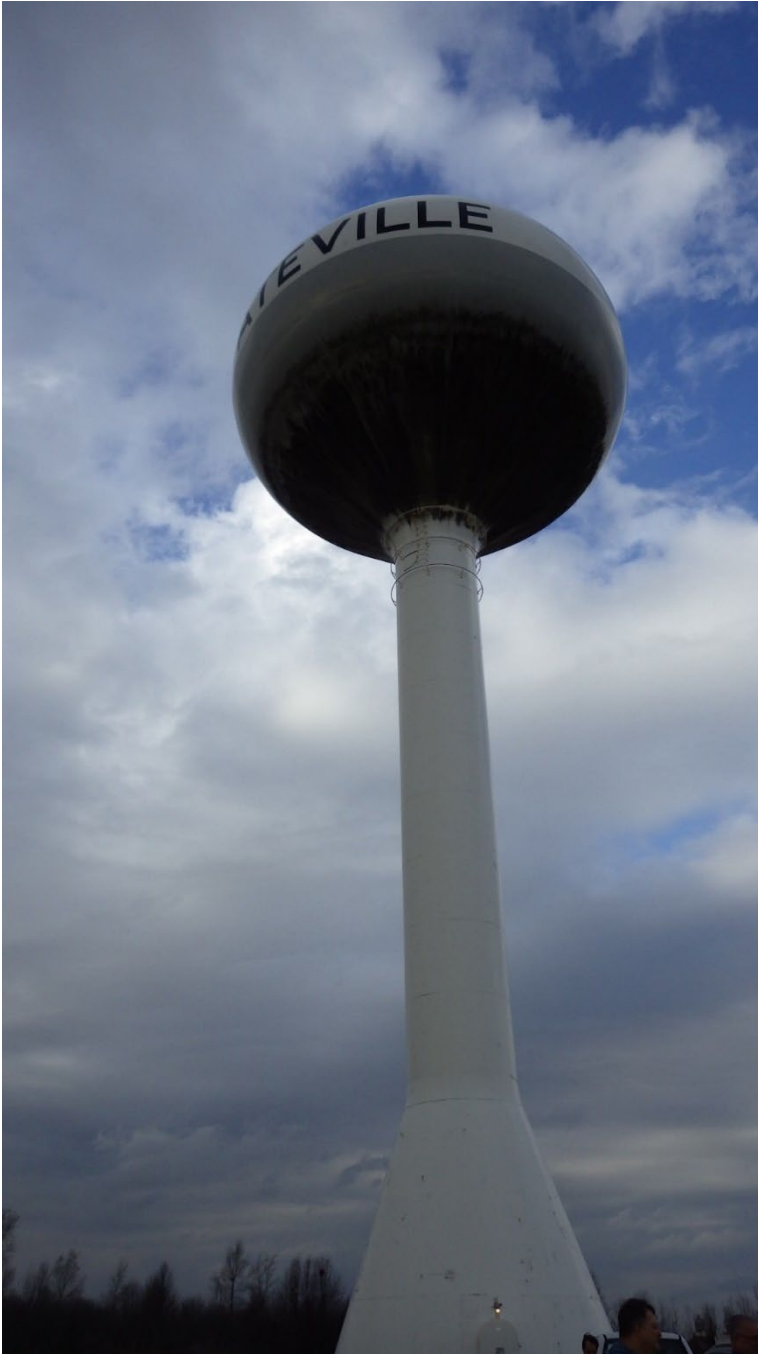
NA	
AOC: EPA observed that exterior base of the water tower was discolored. It appeared the base was covered in mildew and there were signs of peeling paint. AWWA and 10 State Standards recommend finished water storage structures be assessed and inspected (both internal and external) every 5 years to ensure the structures have mechanical integrity and do not pose threat to finished water quality.	
Additional Notes:	
Area: Record Review	
AOC Reference #: RR-008, RR-007 and IN-003	
Regulation:	35 Ill. Adm. Code 604.725(a)
Provides that a minimum free chlorine residual of 0.5 mg/L or a minimum combined chlorine residual of 1.0 mg/L must be maintained in all active parts of the distribution system at all times.	
AOC: EPA identified and the System stated that on numerous occasions the System had daily incoming water free chlorine residuals below 0.5 mg/L.	
Additional Notes:

Description: Exterior of the water tower. At the time of inspection the base of the water tower was covered in what appears to be mildew.
